TRANSPORTATION SAFETY

REFLEXIONS

Issue 19 – January 2002

M A R I N E

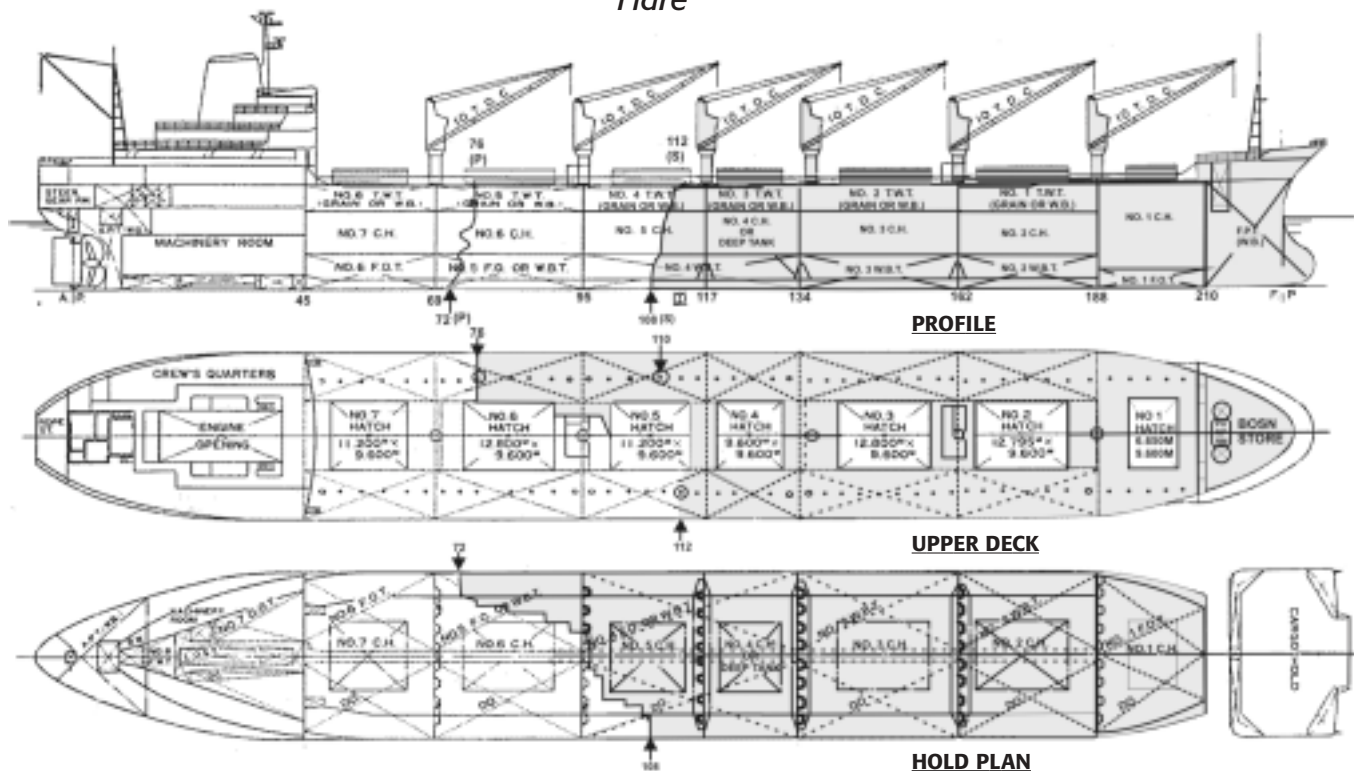
Structural separation location.

loss of longitudinal structural integrity was initiated by rapid brittle fractures in the main-deck plating in way of grain-loading ports and existing fatigue fissure damage near midships. Bottom structural failure, resulting from suddenly imposed compressive loading and excessive localized stress concentrations in way of existing fissure damage, caused the hull to break in two. In addition, the Board found that the loss of life was probably exacerbated by the lack of information from the vessel regarding its location; the MAYDAY was short, incomplete, and difficult to understand, and the EPIRB did not provide any information.

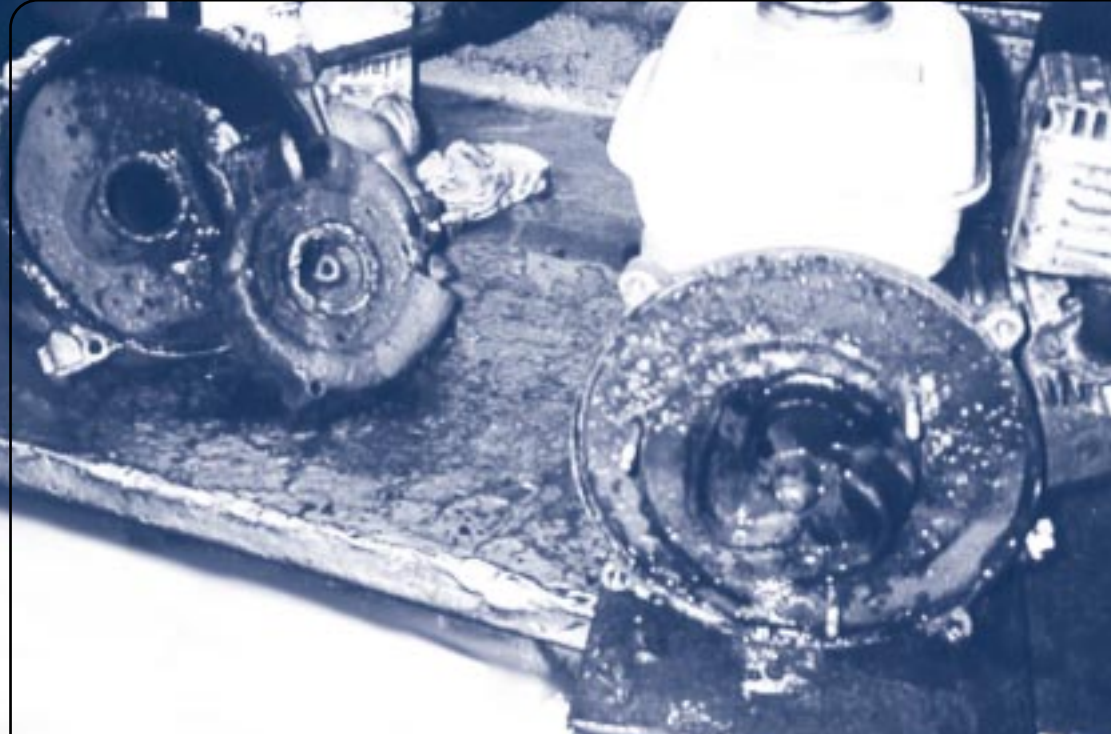
Portable Honda dewatering pump showing dismantled aluminum casing and steel impeller parts severely corroded.

The pump unit lowered to the *Scotia Gold* was similar to the ship's own portable Honda unit. When this second pump was dismantled, the interior was found to be in the initial stages of corrosion. The impeller parts were manufactured from steel, and the pump body of aluminum alloy. A warning in the Honda pump owner's manual cautioned: "to avoid pump corrosion, never pump sea water."

Following the occurrence, the CCG initiated an internal investigation to determine why this particular pump model was used almost exclusively by the SAR units and why the pump delivered to the *Scotia Gold* malfunctioned. As a result, the CCG decided not to purchase any further Honda pumps for SAR duties. Further, the CCG has begun to standardize SAR pumps with equipment that is better suited to the marine environment.

The CCG issued a memorandum to its regions to remind every CCG ship, CCG base, and SAR station to follow the maintenance schedule recommended by the manufacturer in the operator's manual, to rinse pumps and equipment with fresh water after use in sea water, and to test pumps and equipment monthly on vessels and at CCG bases. The memorandum recommended that the Yarmouth-based CCG helicopter carry a drum container, adequately packed and capable of withstanding an air drop. It also recommended that CCG ships, CCG bases, and SAR stations be made aware of the danger of a pump malfunction that

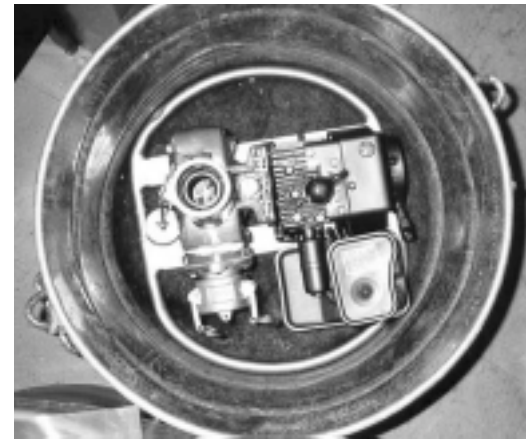
SAR-approved assembly, as carried on CCGC *Cumella*. Unit is held centrally by circular base, with ample clearance around components.

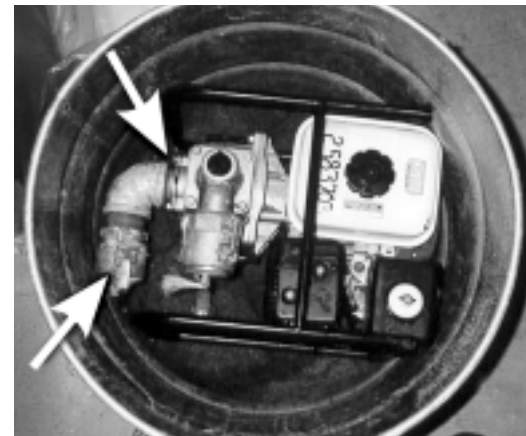
The CCG pump had been packaged for SAR using a drum container originally designed for a portable pump made by another manufacturer. The Honda pump originally would not fit into the aluminum drum container and had been adapted locally to fit. Fitting the adapted pump unit into the container forced the flanged suction pipe hard up against the inside of the container wall. A fracture in the pump's suction flange propagated from this contact point and caused the pump to fail.

CCG helicopter-delivered Honda unit, tightly fitted into the drum. 'A' indicates contact point of pump with drum. Location of suction flange fracture is shown at 'B'.

could result from strong impact and take appropriate measures regarding drum container packing.

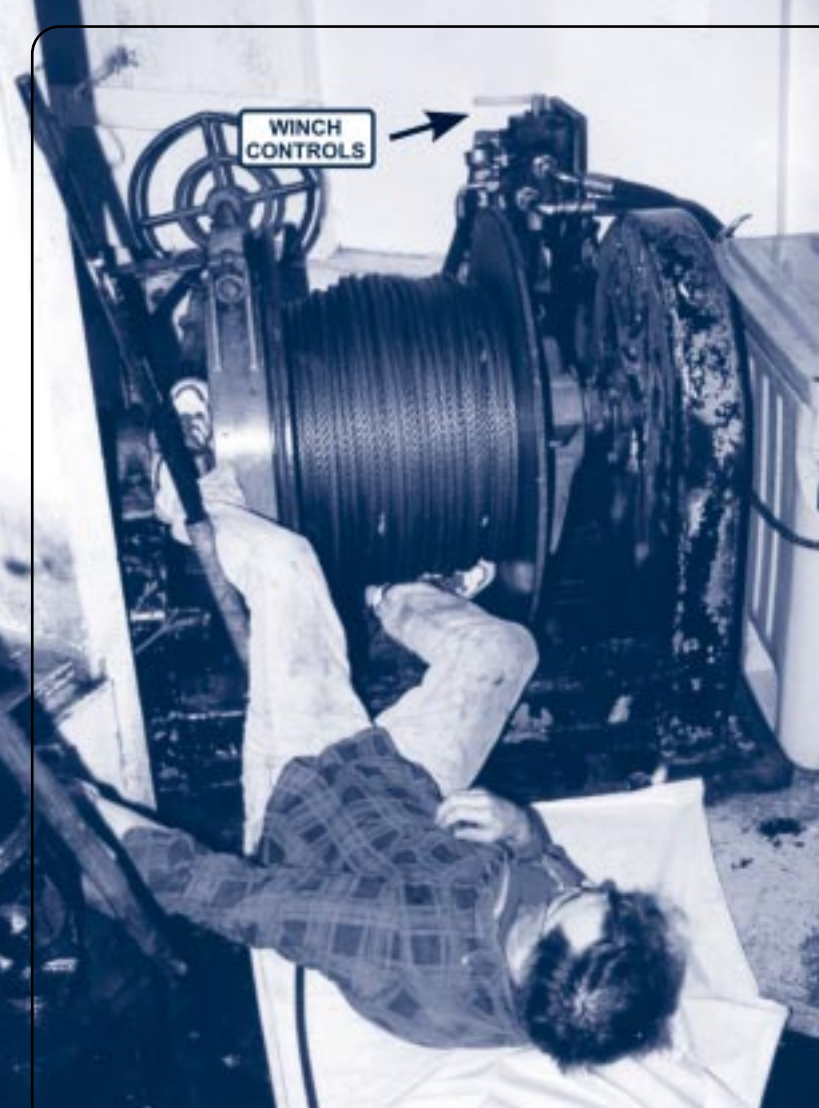
Re-enactment of events leading to right foot becoming crushed between incoming wire rope and rotating winch barrel.

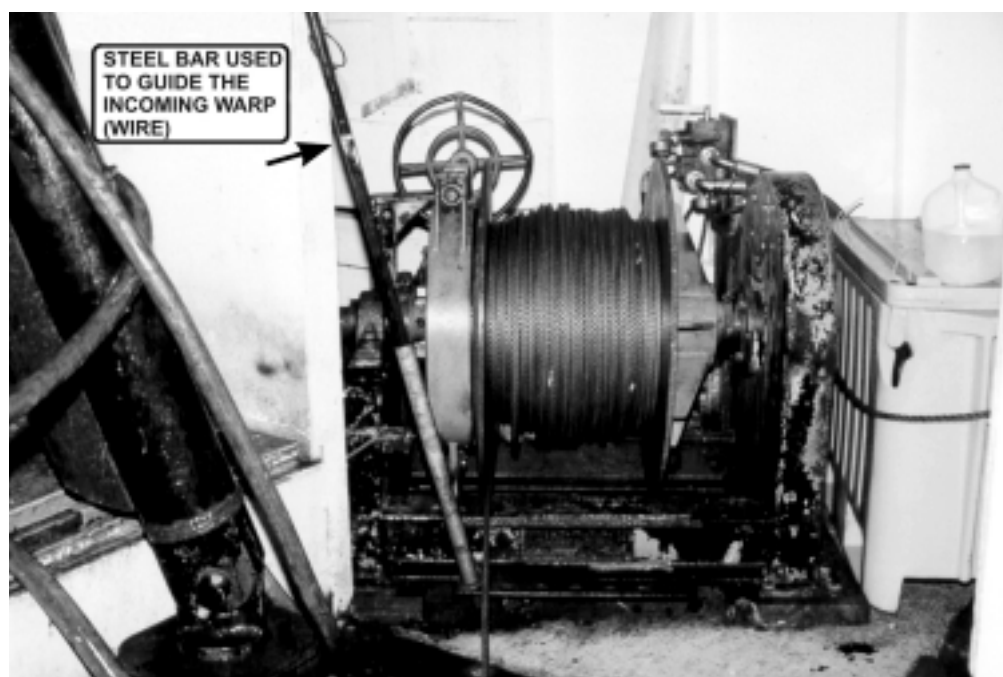
General view of winch on after-deck of *S.S. Brothers*.
